# PV Module forensics

Characterization of module materials in the field

**Dr. Gernot Oreski**

Pearl PV Training School  
Enschede, 09.03.2022

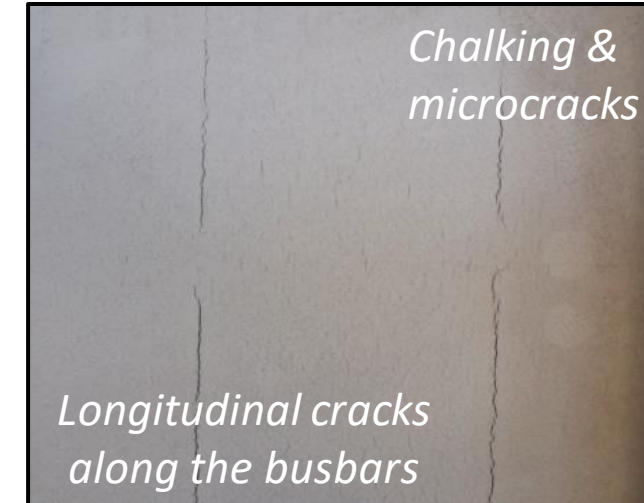
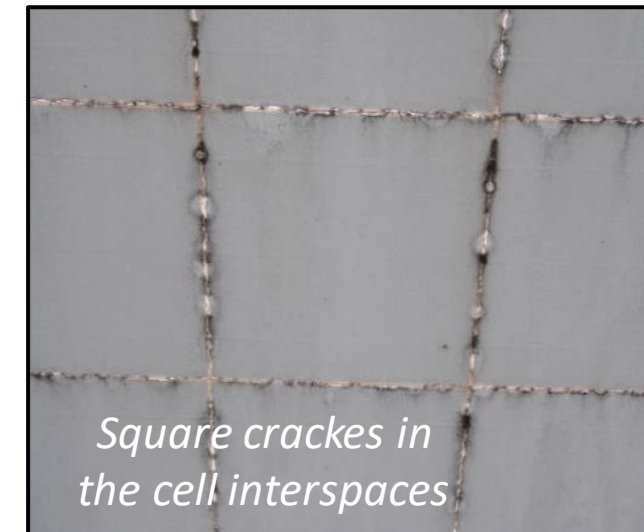
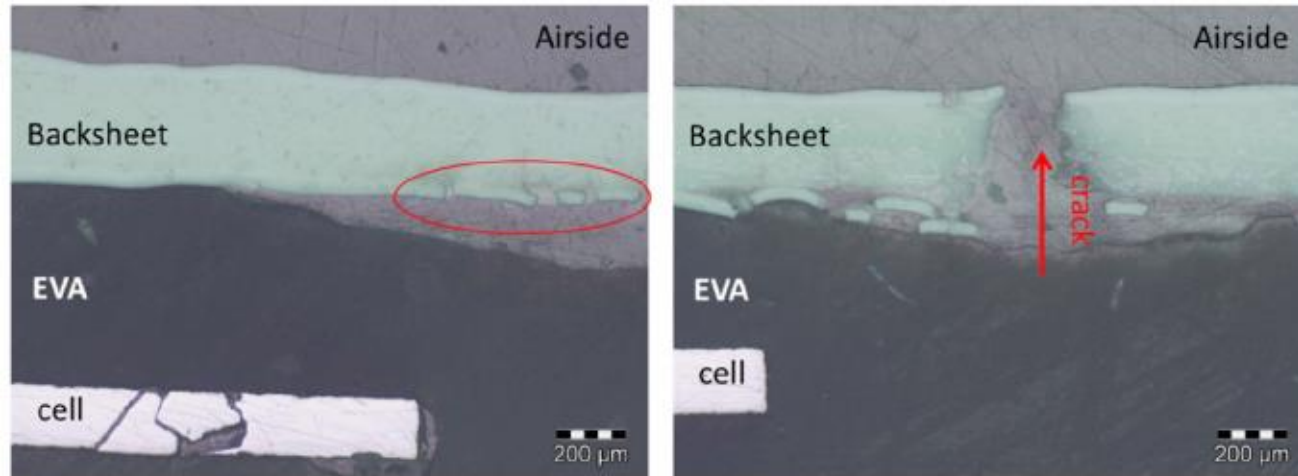
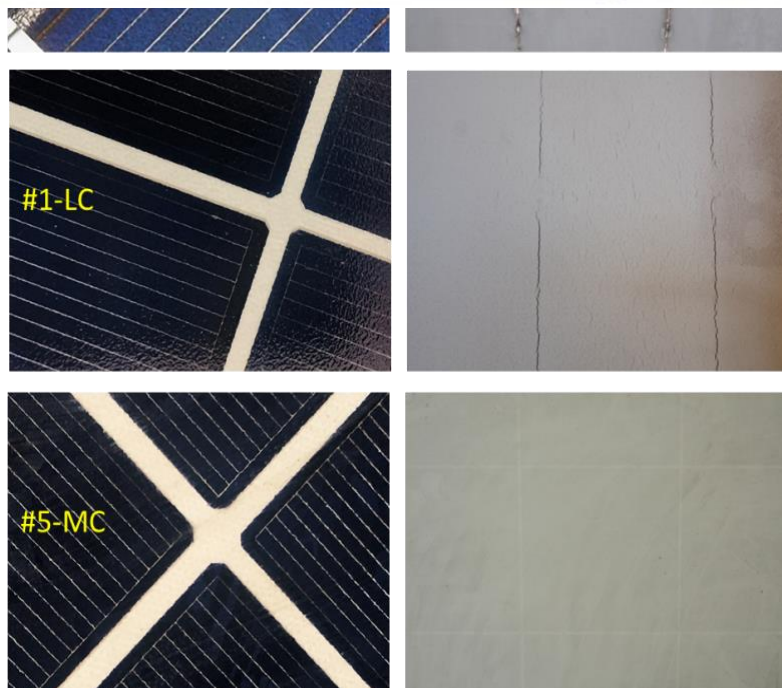
*Unforeseen cracking of AAA  
backsheets after some years  
in the field*

- Cracking of PA backsheets after 5-8 years in operation
- No cracking during accelerating indoor testing

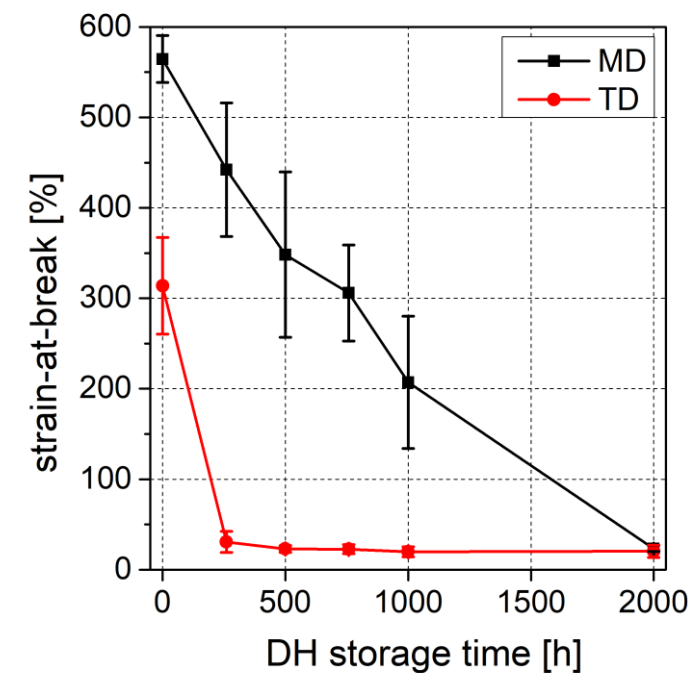
**Physical aging process of PA12 significantly reduces the ability for plastic deformation of the backsheet**

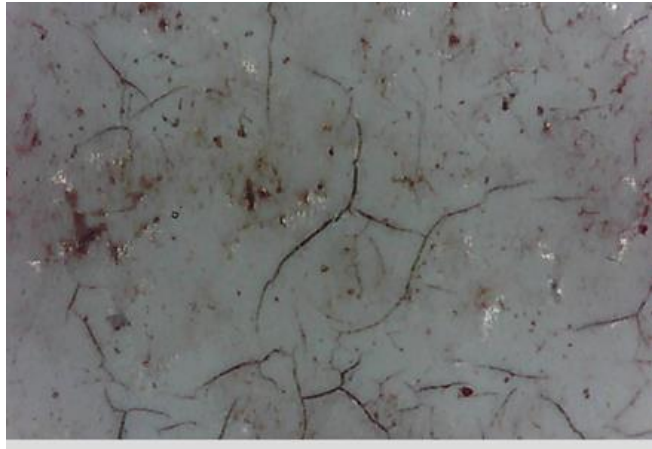
- ✓ Formation of micro-cracks at local stress concentrations

→ Daily and seasonal temperature changes in combination with different thermal expansion coefficients of PV materials cause thermo-mechanical stresses

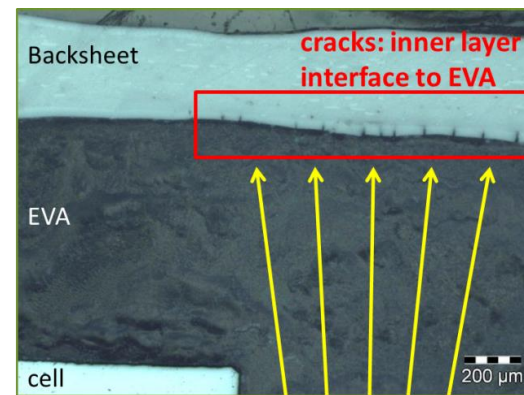
UV radiation in the cell interspaces

- ✓ Strong photo-oxidation and cracking of inner PA layer due only in combination with **high acetic acid concentration** and a **phosphor additive**

- ✓ Cracking of strongly oxidized inner PA layer  
→ **Square cracks**
- ✓ Height of ribbons impose additional tensile stress  
→ **Longitudinal cracks**
- ✓ Chalking does not have an impact on crack formation

Weak chemical resistance of PA12 towards acetic acid and weak to moderate resistance towards phosphoric acid compounds [12]

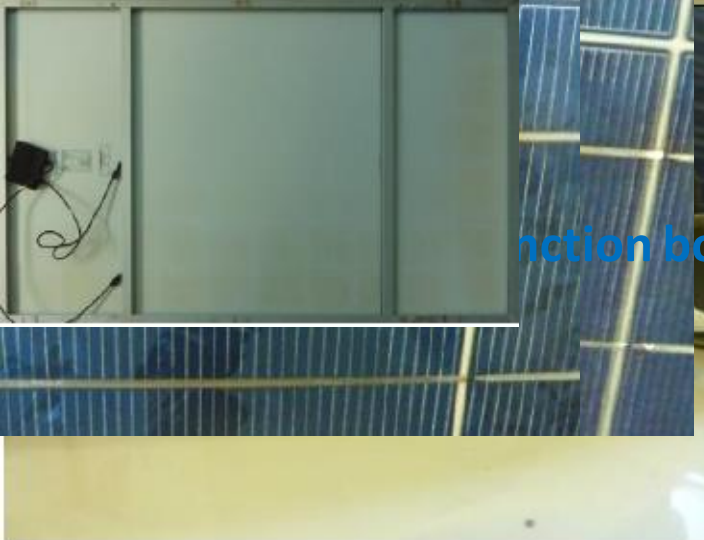
Junction box (JB)

*JB adhesive failure at backsheet surface*

- ✓ *Processing: Surface cleaning and incomplete crosslinking of adhesive*
- ✓ *Degradation (adhesive; backsheet)*
- ✓ *Different Bill of Materials*

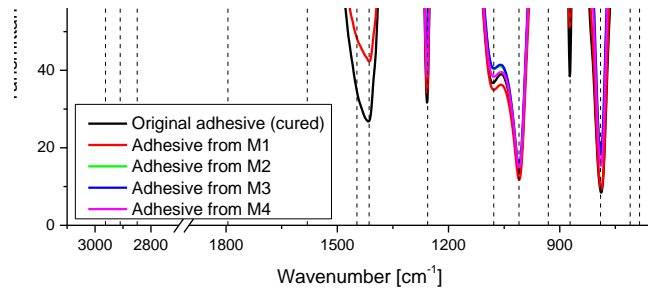
- ✓ *Two different types of silicone based JB adhesives are identified*
- ✓ *The main differences between the two categories are the intensities of the peaks at around 1447, 1414, 870  $\text{cm}^{-1}$ , as well as in the region below 710  $\text{cm}^{-1}$*
- ✓ *No peak or shoulder at 931  $\text{cm}^{-1}$  visible*  
→ **JB adhesives fully crosslinked**
- ✓ *JB adhesives belonging to M1 and M4 show the same characteristic peaks as the original adhesive, whereas for M2 and M3 an alternative adhesive was used*
- ✓ *Module M3 with detached junction box has alternative adhesive*

***Different type of adhesive may be main cause for adhesion failure of junction boxes***

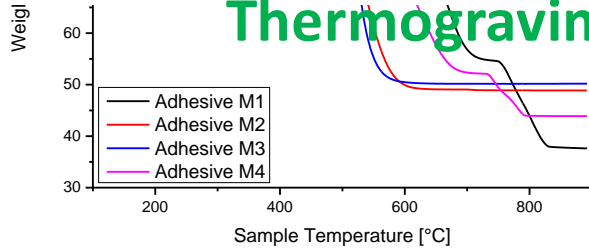
### Two different types of JB adhesives are identified

- ✓ Adhesives from M1 and M4 correspond to the original adhesives
- ✓ An alternative adhesive for M2 and M3

### Different filler contents

- ✓ About 37 – 44% for original adhesive
- ✓ Around 50% for alternative adhesive

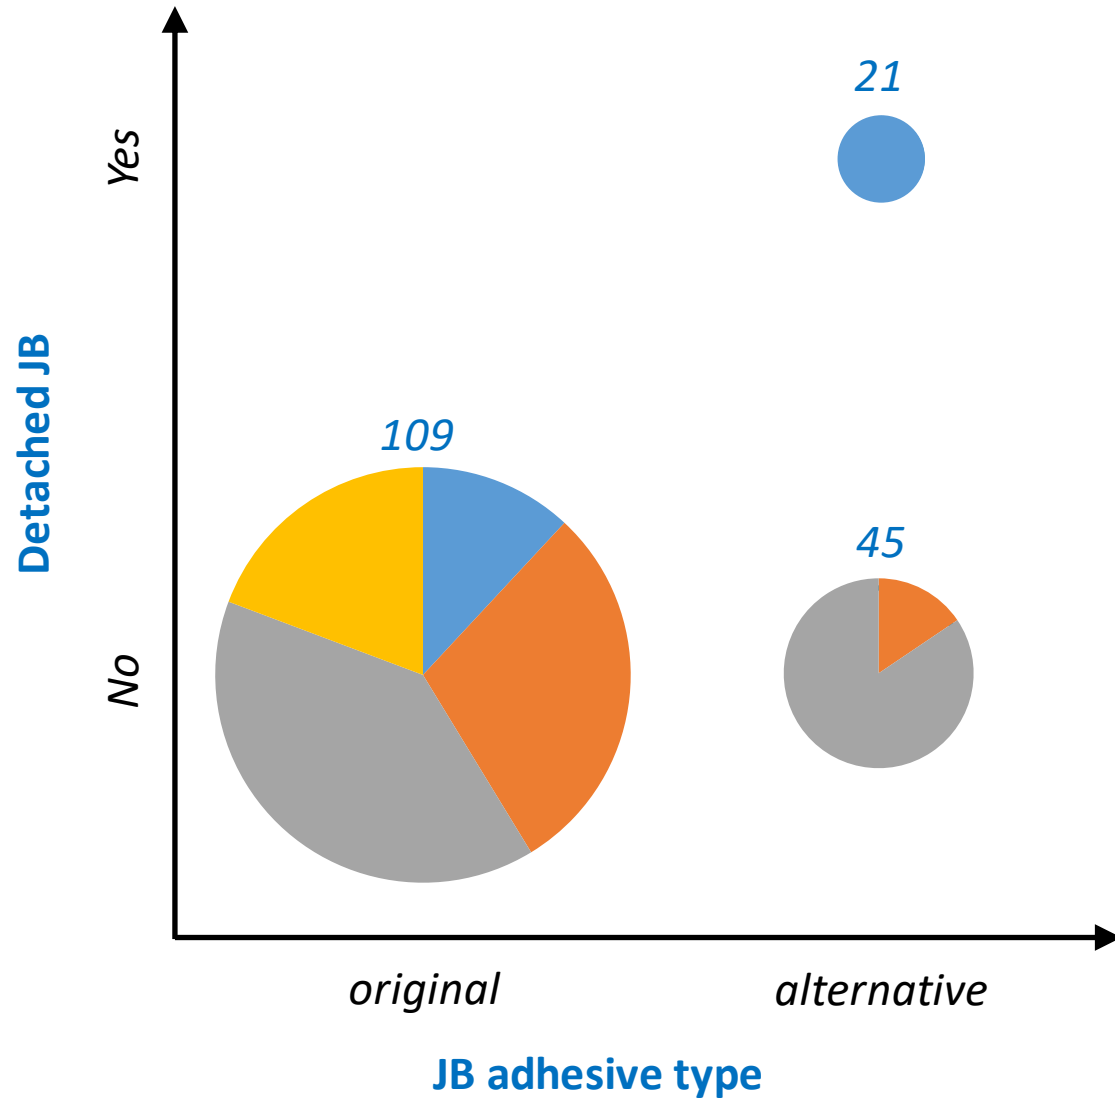
- ✓ Random use of alternative adhesive for junction boxes
- ✓ BOM states only one adhesive for all modules
- ✓ Adhesion failure is just observed for modules from the Caribbean using alternative adhesive

- ✓ *JB adhesive specified in BOM works fine*
  - ✓ *Backsheet degradation and insufficient curing is ruled out as root cause*
- **Results confirm importance of an incoming inspection of PV modules before installation with respect to its BOM**

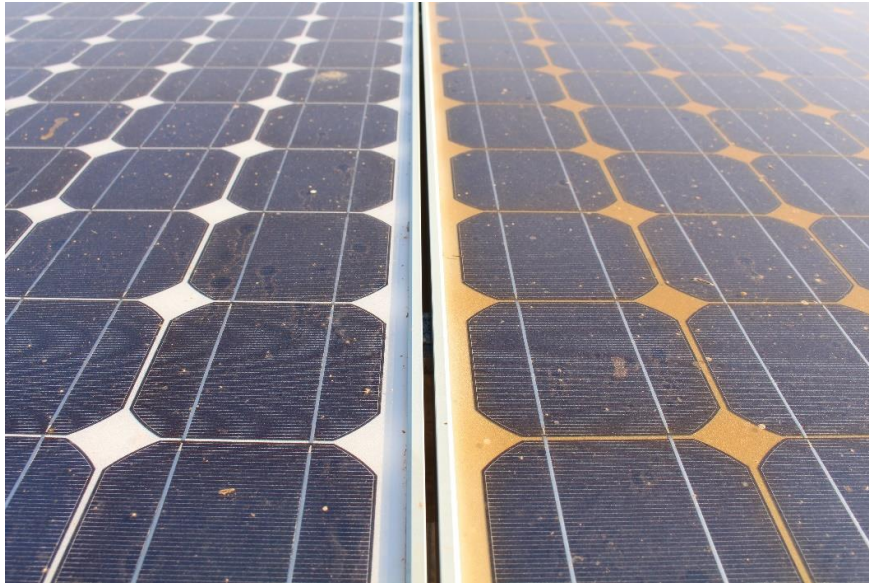
***Yellowing at backsheet - encapsulant interface:***  
*Formation of oxidized antioxidants with  
conjugated double bonds*
