Combined-Accelerated Stress Testing of PV Modules and Materials

Michael Owen-Bellini

PEARL PV

February 2nd 2021

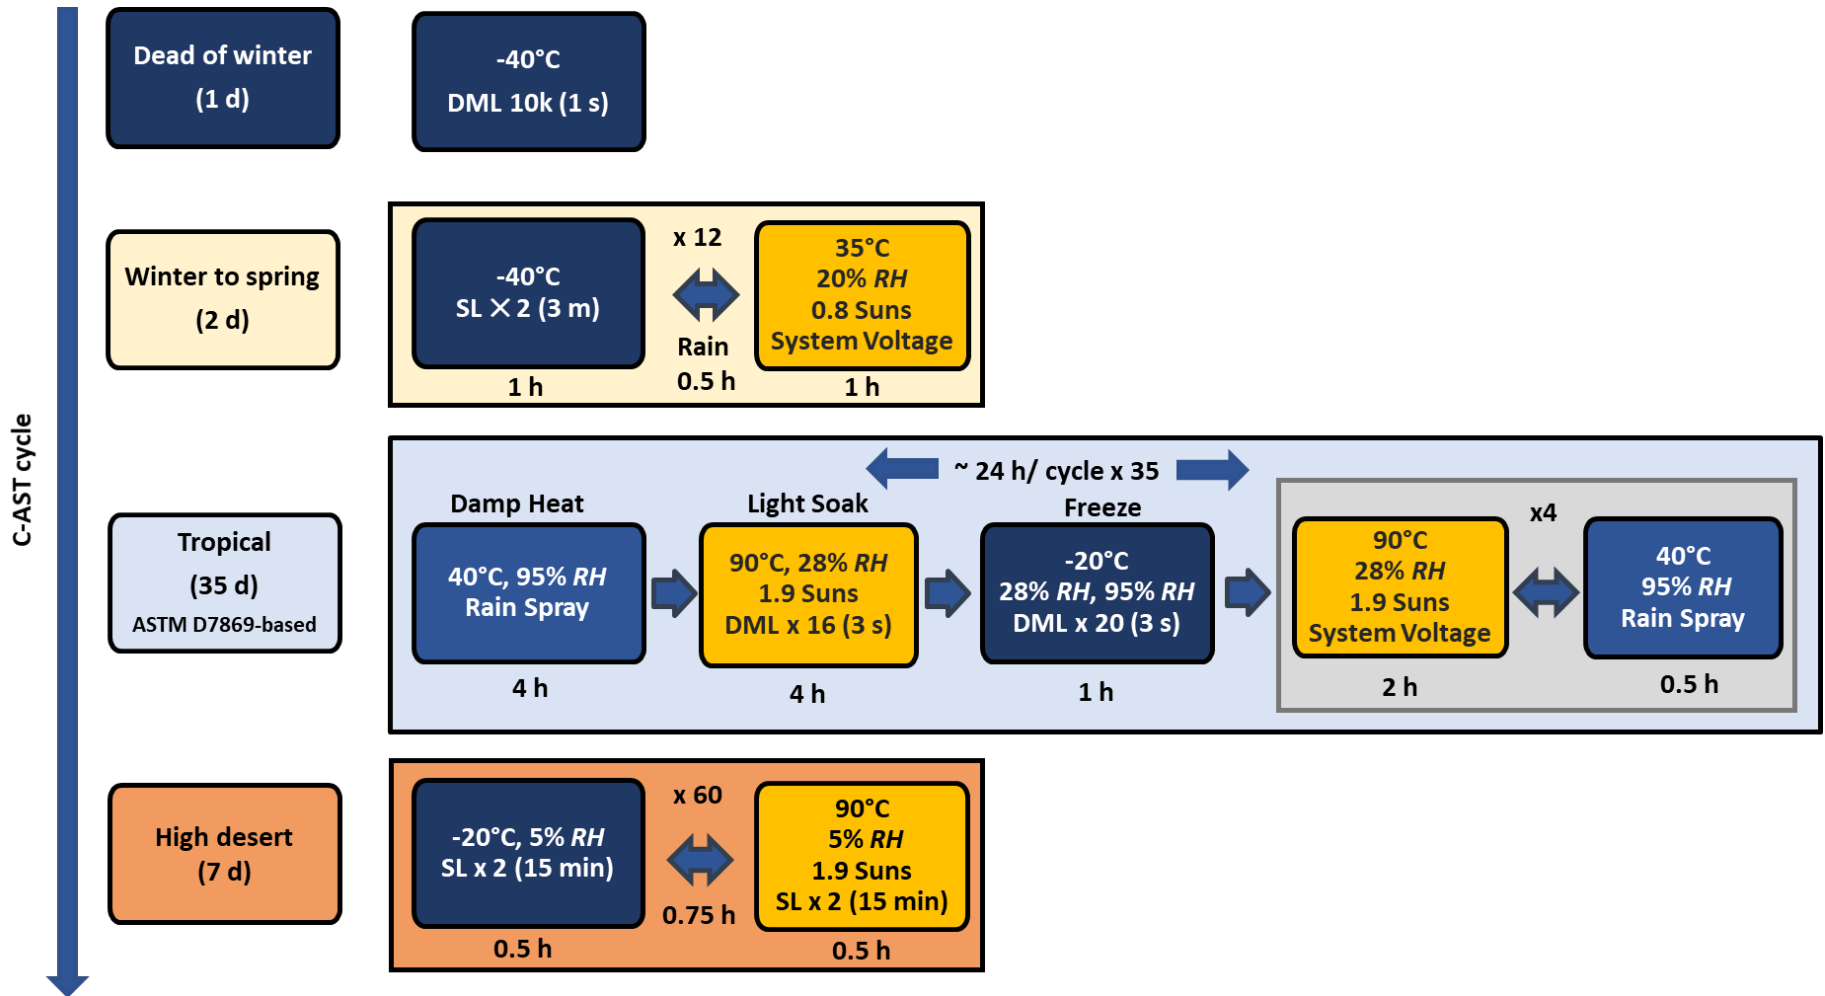
Combined-Accelerated Stress Testing: Test Protocol

DML = Dynamic Mechanical Loading
SL = Static Loading

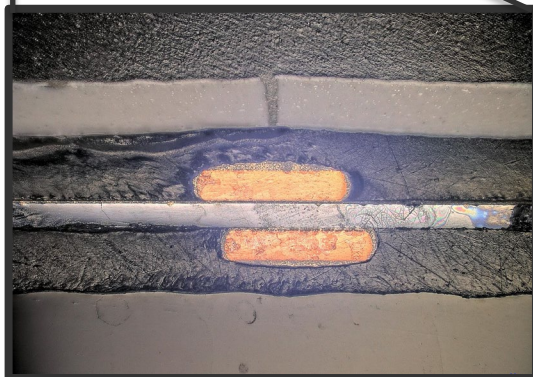
Surface micro-cracking
covering entire backsheet
surface
