UNDERSTANDING POTENTIAL- INDUCED DEGRADATION (PID) OF PHOTOVOLTAIC (PV) MODULES

DR MAHMOUD DHIMISH
UNIVERSITY OF YORK, UK

PEARL PV'S TRAINING
SCHOOL ON THE POTENTIAL
OF MONITORING TOOLS AND
ADVANCED OPERATION AND
MAINTENANCE PRACTICE
FOR SECURITY AND
PREDICTABILITY OF PV
PERFORMANCE

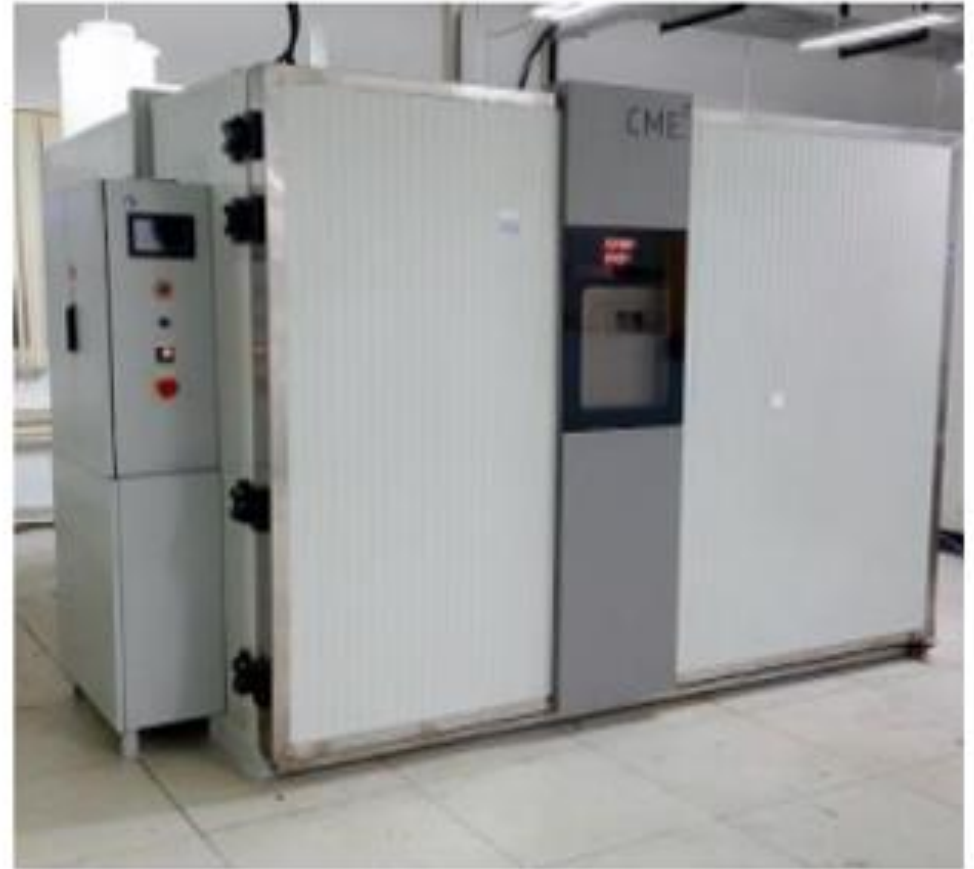
TESTING PROCEDURE - INDOOR

80% relative humidity, 85°C and biased with a voltage of -
1000 V, for 96 hours

PV Module
