**Failure Detection in the Field** EU Cost Action PEARL PV Seminar PV Reliability and Durability Malta, 14 October, 2019

Ulrike Jahn TÜV Rheinland Energy GmbH 51101 Cologne, Germany Ulrike.jahn@de.tuv.com http://www.tuv.com/solarpower

- Degradation mechanisms
- Failure modes, origin & detection
- Inspection methods for PV power plants
  - Visual inspection
  - On-site I-V measurement
  - Infrared thermography
  - Electroluminescence analysis
- Summary & lessons learnt

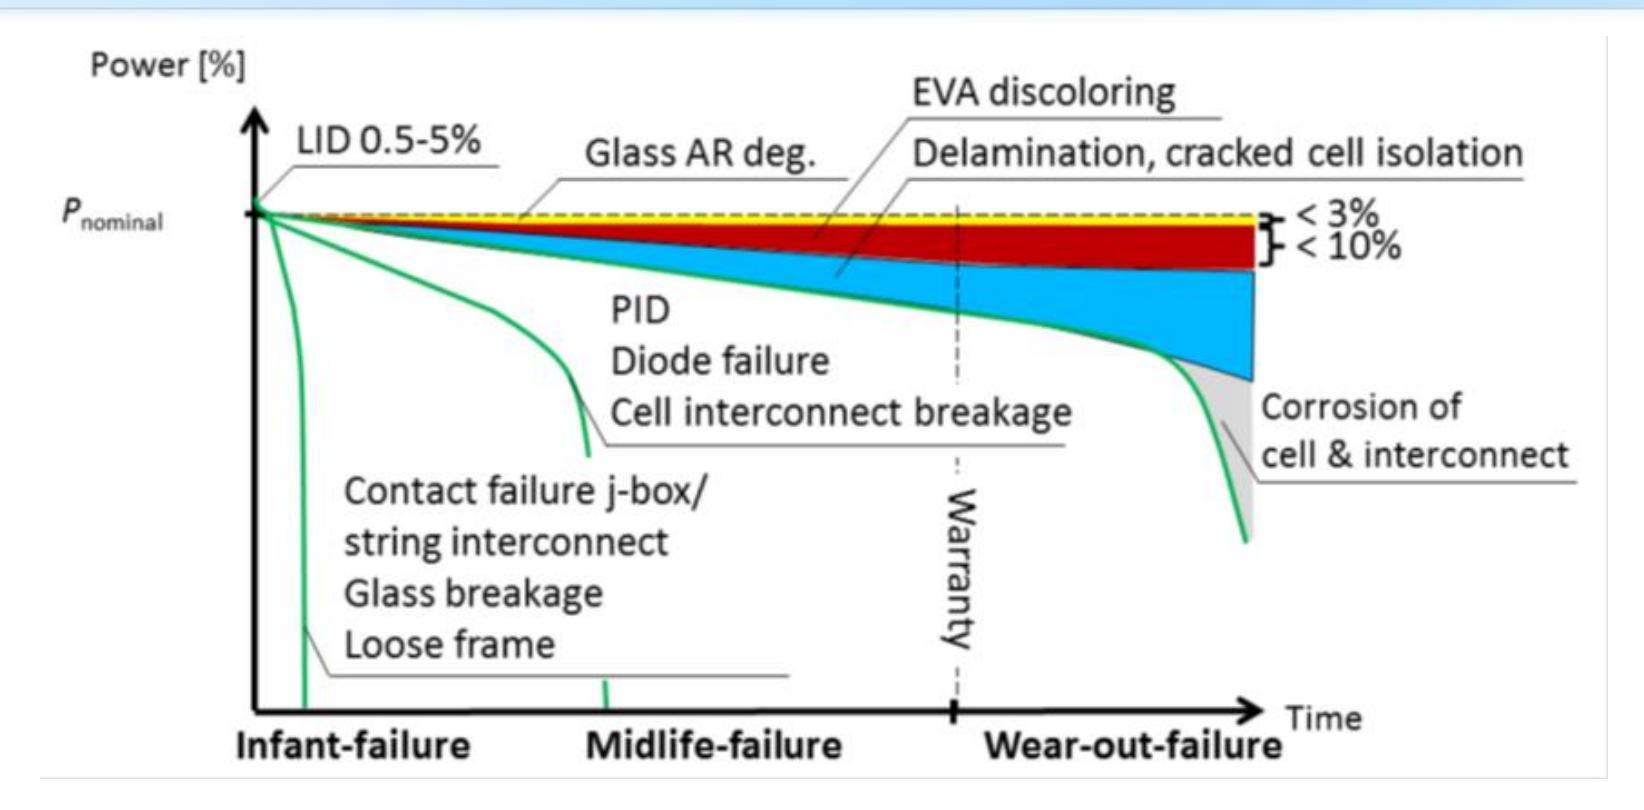
Infant failure or early failure occur in the beginning of the working life of a PV module.
<u>Origin</u>: Defective construction, faults in production and non-conforming materials.
Mid-life failure occurring up till 10-15 years of operation are termed as midlife failures.
Wear-out failure occurring late in PV module lifetime.

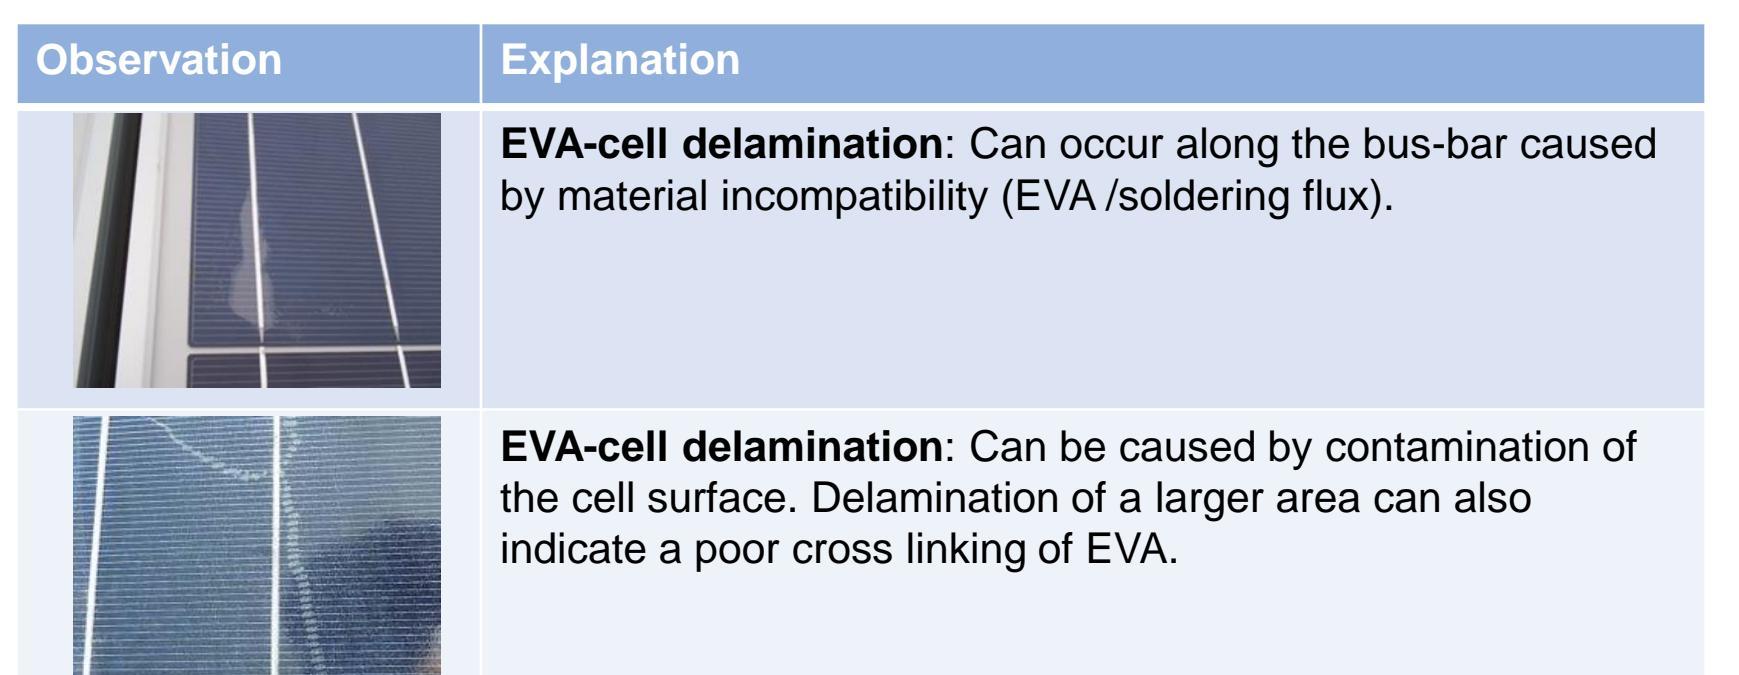
Any delamination can cause voids or air bubbles in the laminate. Air bubbles are potential areas for humidity accumulation, which may lead to corrosion of metallic parts or short circuits.

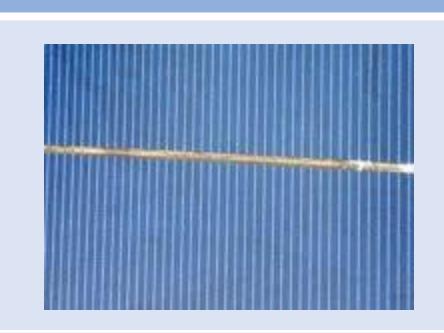
#### Solder ribbon discoloration:

This type of discoloration can be a result of corrosion or the result of light-sensitive flux residues on the ribbon.

This type of discoloration will rarely result in power loss.

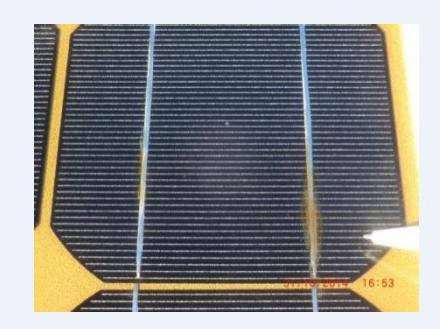
#### **Corrosion of metallic parts:**

Humidity ingress into the encapsulation will lead to corrosion of metallic parts in the interconnection circuit. Corrosion effects at cell front electrode (grid finger, busbar, cell interconnect) are most prominent.

Corrosion processes can be also caused by formation of acetic acid in EVA.

Corrosion will lead to continuous increase of the internal series resistance of the PV module, which is associated with power loss.

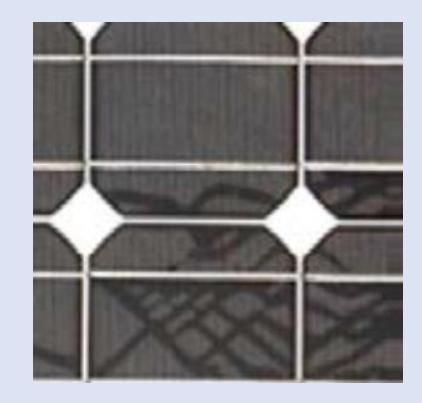
#### **Snail trails:**

Brownish discoloration of the silver fingers (front metallization) of screen printed solar cells. The discoloration occurs at the edges of the solar cell and along invisible cell cracks.

Root cause: Moisture ingress through cell micro-cracks leading to chemical reaction (in combination with UV) and resulting in deposition of silver from fingers and bus bars into EVA.

Discoloration happens with specific EVA formulations (Peroxide additives) and specific silver paste. For certain material combinations snail trails will not occur.

Snail trails are not serious but the crack it reveals can be.

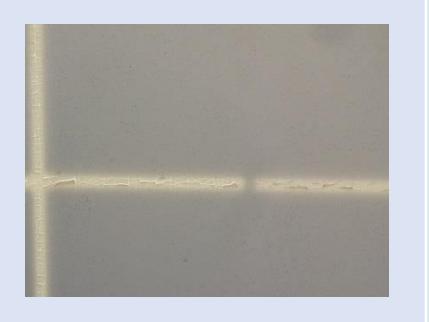
UV irradiance reaches the backsheet through the cell interspaces, where photo-degradation processes are induced. Low quality backsheets are UV sensitive, resulting in a loss of mechanical properties (elastic behavior) and crack due to thermomechanical stresses.

Once the back sheet is broken, it cannot provide the electrical safety. This problem is serious.

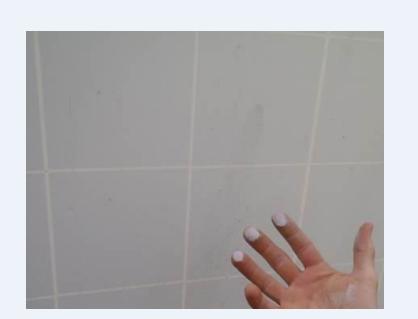
Weathering effects will continuously reduce the thickness of the backsheet outer layer:

- Photocatalytic degradation
- Erosion by sand abrasion

An attending effect can be so-called chalking of the backsheet, which typically appears as a fine powdery residue on the surface. Organic molecules are removed from and the inorganic filler particles such as  $TiO_2$  are exposed.

Back sheet chalking and backsheet cracking often occur at the same time.

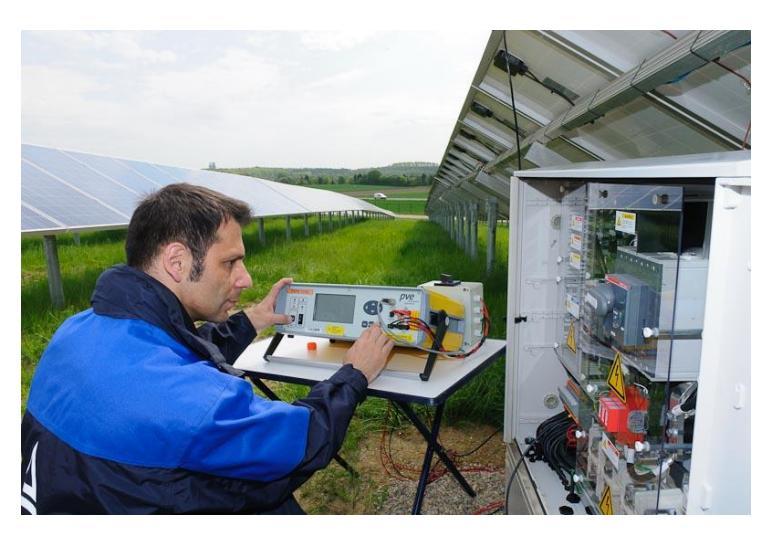
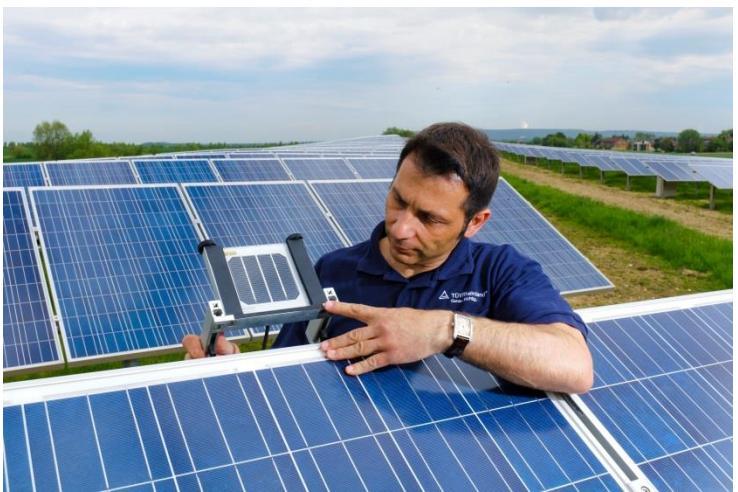
- Performed with commercial I-V curve tracer
- Measurement of single PV module or a string of serially connected modules
- 4-wire connection between field terminal box and I-V curve tracer
- Other input channels for irradiance sensor and module temperature sensor, which are to be installed in the field.
- PV array measurements reveal interconnection failures of PV modules or detect low power of modules. But it but does not allow conclusion on output power of individual modules.
- This confirmation is possible with mobile test centers or shipment of samples to test laboratory.

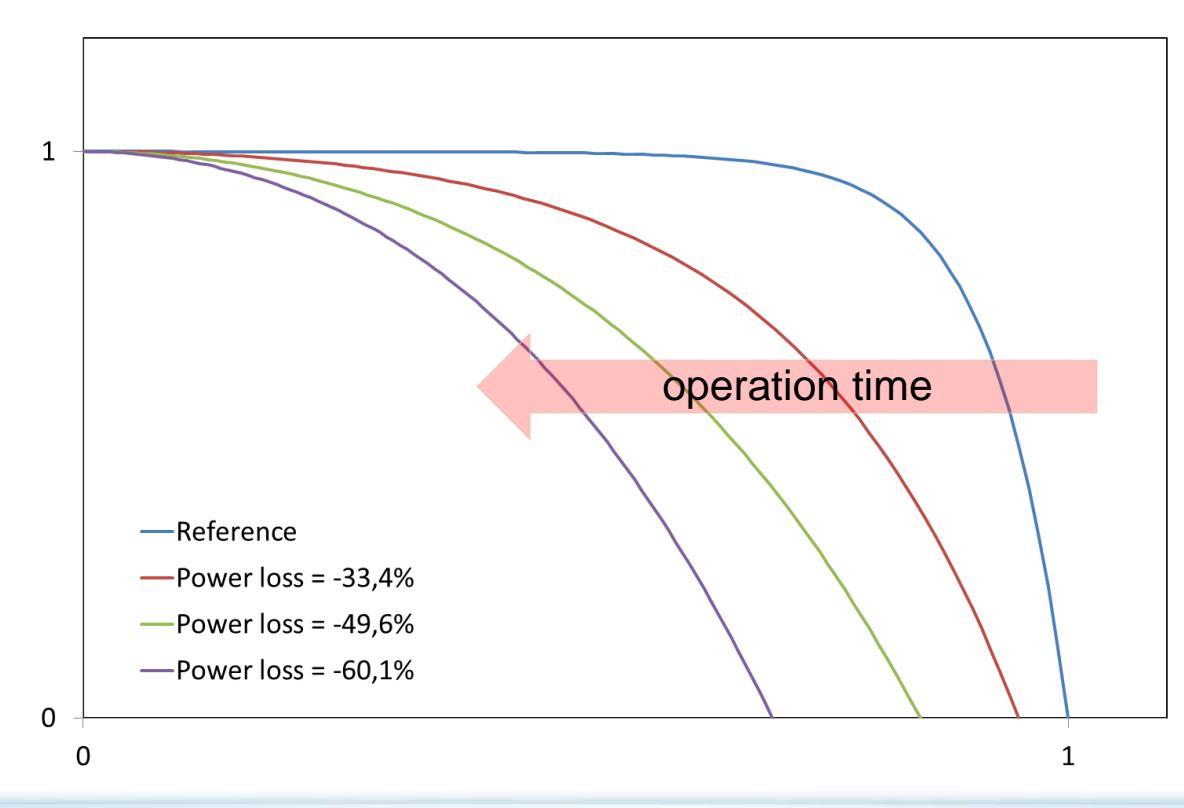
- If PID sensitive modules are installed, the
- Local climatic conditions influence the degradation rate (humidity, time of wetting, etc.)
- Degradation increases with operation time of the PV power plant
- PID affects the slope of the I-V curve at Isc and causes a Voc decrease

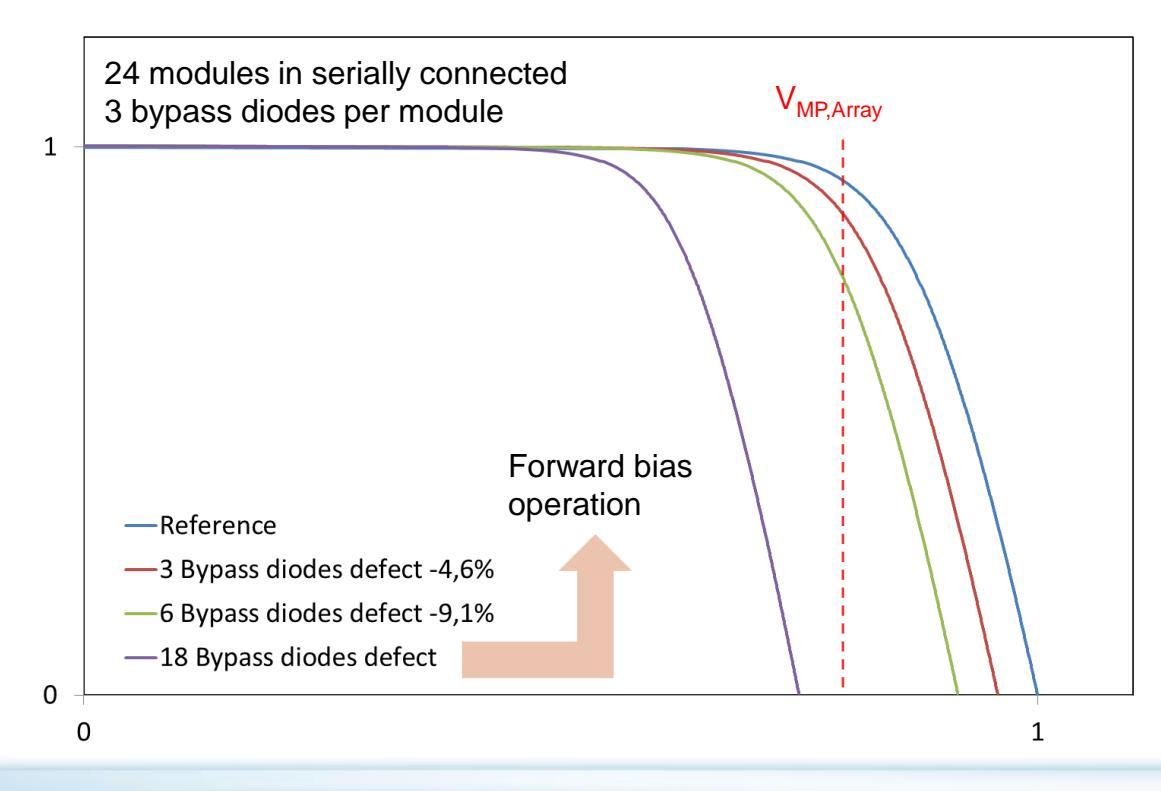
- Defective bypass diodes are typically conductive (thermal overload, electromagnetic pulse, etc.)
- The respective section of the cell interconnection circuit in a PV module is shorted
- High number of defective bypass diodes may lead to Voc variation of module strings, which may cause reverse current flow.

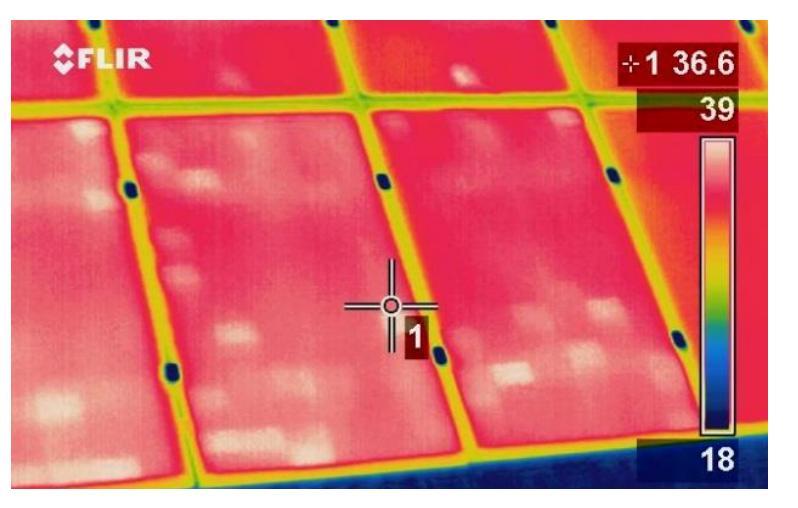
- The temperature distribution of a PV module is typically not uniform (chessboard pattern)
- Temperature differences less than 10 K, which are caused by cell production tolerances (bulk resistance), can regarded as normal.

Normal heat generation  $\Delta T < 10 \text{ K}$

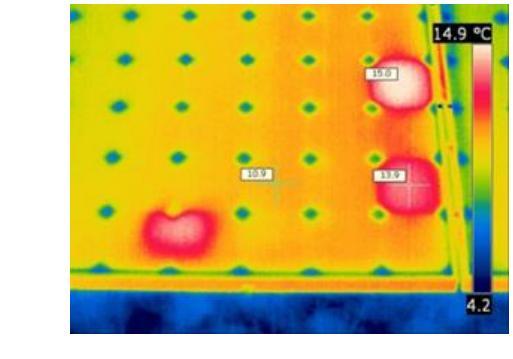
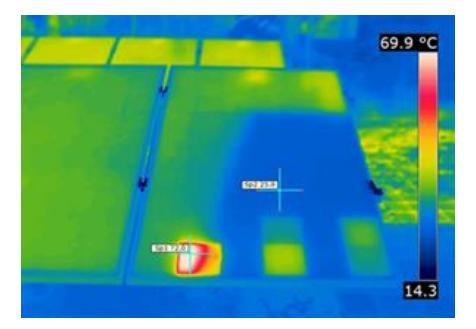
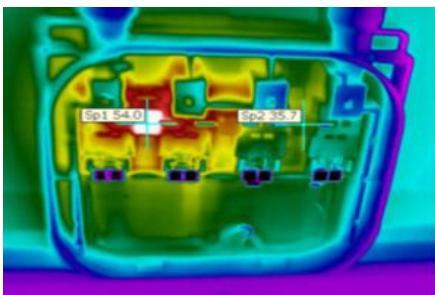
If single cells in the module do not electrically match in short circuit current, or if various power classes for cells are used in a module temperature difference larger than 10 K can be observed. Cell with lower  $I_{SC}$  will generate heat.

If a crack separates a part from a solar cell, this cell is driven in reverse bias and will dissipate power. This defect will only lead to abnormal heating if the size of the separated part is larger than  $(1 - I_{MP}/I_{SC})$  of the cell size, which is approx. 10%.

Bypass diodes turn on when single cells deliver less photocurrent than the maximum power current of the string. Power dissipation due active bypass diode leads to higher module temperature in the module area around the junction box.

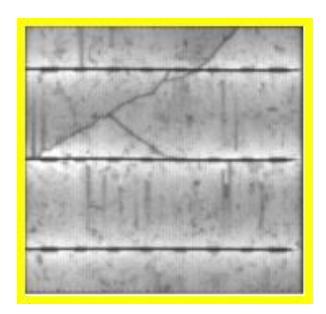
#### Cell cracks <u>without</u> separating parts of a cell:

- Negligible impact on power
- Unclear crack propagation and evolution of degradation (snail trail, separation of cell parts, burn marks, etc.)

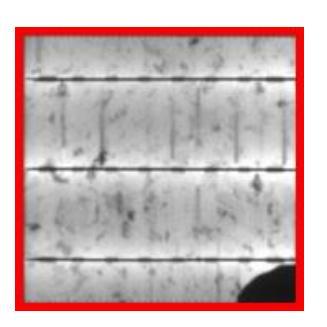
#### Cell crack with separating a part of a cell:

- Negligible impact on module output power if area of separated part is lower than 10% of cell area.
- Abnormal heating effect if cell area of separated part is larger than I<sub>MP</sub>/I<sub>SC</sub> ratio (condition for reverse bias operation).
- Heating will enhance material degradation.

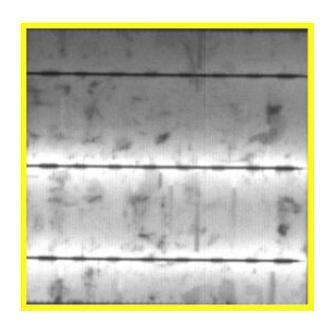
#### Crack of cell interconnect:

- No or reduced current flow through top cell ribbon
- No noticeable effect on module P<sub>MAX</sub>
- Unclear long-term effects due to thermo-mechanical stress (burn mark caused by arcing)

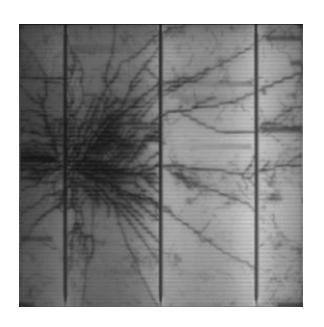
#### Cell cracks caused by hail impact

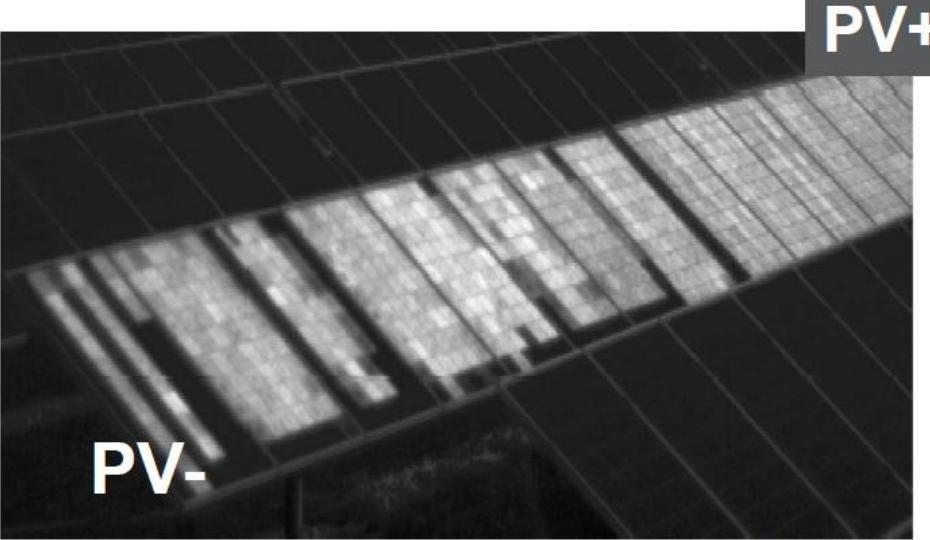
PID-affected cells appear darker during current injection in the dark (Lower cell voltage due to shunting)

#### **Typical PID patterns:**

- Half of the string, which is close to the positive PV+ pole, shows no PID
- Patchwork of PID affected modules is caused by variable operating conditions (electrical contact, condensation, rain)
- Bottom row of cells is heavily affected (worst conditions for PID)
- Stripes of affected cells indicate use of two cell types (two stringers for cell feed in production line)
